Cyclic behaviour of *Pombalino* “frontal” walls

H.A. Meireles & R. Bento

ICIST, IST, Technical University of Lisbon, Portugal

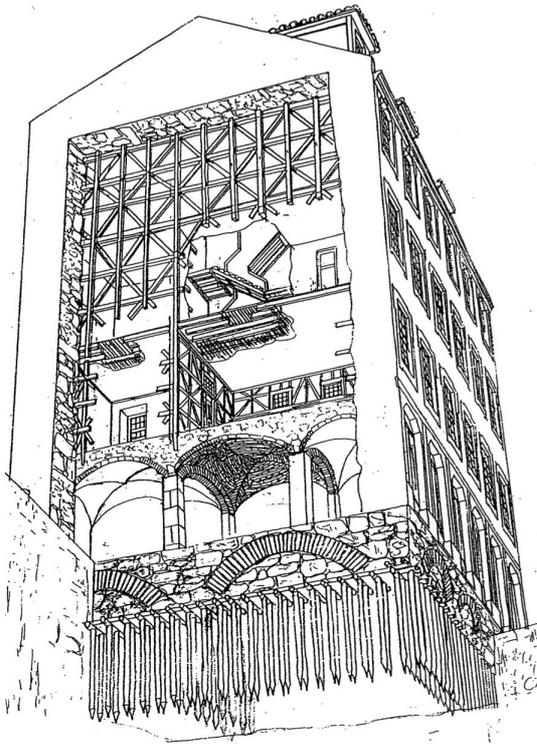
Figure 1: Example of a *Pombalino* building [Jorge Mascarenhas, 2005].

The mixed wood-masonry XVIII century *Pombalino* buildings of downtown Lisbon have a recognized patrimonial value both nationally and internationally. In 1755 a catastrophic earthquake followed by a considerable tsunami stroke the capital of Portugal causing severe damage to the city. The event completely destroyed the heart of the city, which was set on a valley area close to the river Tejo and is composed of a shallow layer of alluvium material. The disaster required an urgent solution. The Prime Minister at the time, Marquis of *Pombal*, was set responsible for the reconstruction of the city and to bring it back to normality as fast as possible. Then, he delegated to a group of engineers the development of a structural solution that would guarantee the required seismic resistance of the buildings. Based on the know-how of that time and on the empirical knowledge gathered from the buildings that survived the earthquake a new construction type was created, this being generally referred to as *Pombalino* construction nowadays. An example of the constructing elements that compose a *Pombalino* building can be seen in figure 1.

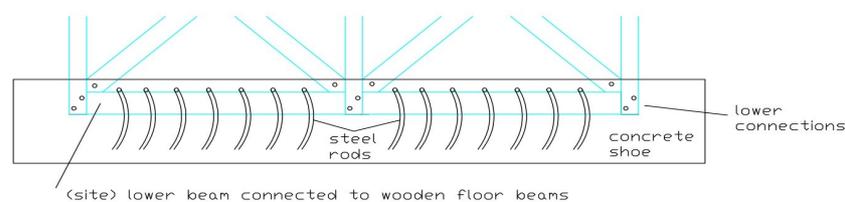
Figure 2: Schematic drawing of concrete shoe for support conditions in experimental set-up of Pompeu Santos [1997].

Very few data, analytical and experimental, exists on the behaviour of the “frontal” walls. Such data can be obtained from experiments consisting of physical tests of representative specimen. For this reason it urges to carry out experimental work that can further back up analytical computer models. The experimental activity carried out on these walls so far is limited to Pompeu Santos [1997] and Cruz *et al.* [2001]. In the fist paper referred, three (although not exactly with the same configuration or dimensions) real site specimen were transported to the laboratory and further tested under reversed cyclic loading with imposed displacements. The study was the first to test such walls under static cyclic shear testing but in these tests no specific loading protocol was used and it is important to mention also that no vertical loading was applied to the structure. These two aspects are seen to be downside of this study. Furthermore, although the experimental work has the advantage of using real site specimen, this fact has also disadvantages with regards to the difficulty of transportation of the specimen to the laboratory and reproduction of the real support (boundary) conditions expected in the building. For the transportation a steel cage was built minimizing the deformations and shocks on the specimen; for the support conditions it was built a concrete shoe plate to assure that the lower horizontal beam would remain still with relation to the ground floor (see figure 2).

Even though, when using real site specimen, it seems that this type of support could not be avoided, it has the immediate disadvantage of seeing the lower connections of the vertical to horizontal beam being covered by the concrete shoe. It is believed by the authors that this solution for the support conditions increases the stiffness and strength of the tested walls when compared to the reality of the site (at the site only the lower wall beam is connected to the wooden floor joists). On the second paper mentioned it was intended to assess the possibility and efficiency of using FRP rods and glass fibre fabric, together with epoxy adhesives, in the strengthening of damaged “frontal” walls. What is relevant to point out on this experimental work is that scaled models (1:3) of the wall panels were built and tested in diagonal compression (under monotonic loading). Although these tests are much less time consuming and easy to perform than panel shear tests on real size walls, the data obtained with monotonic testing is preliminary and limited to the most to envelope curves on force-displacement relationships of scaled models. For the detailed seismic analysis foreseen for the current study it is required to test the specimen under reversed cyclic loading to obtain the desired hysteresis behaviour of such walls.

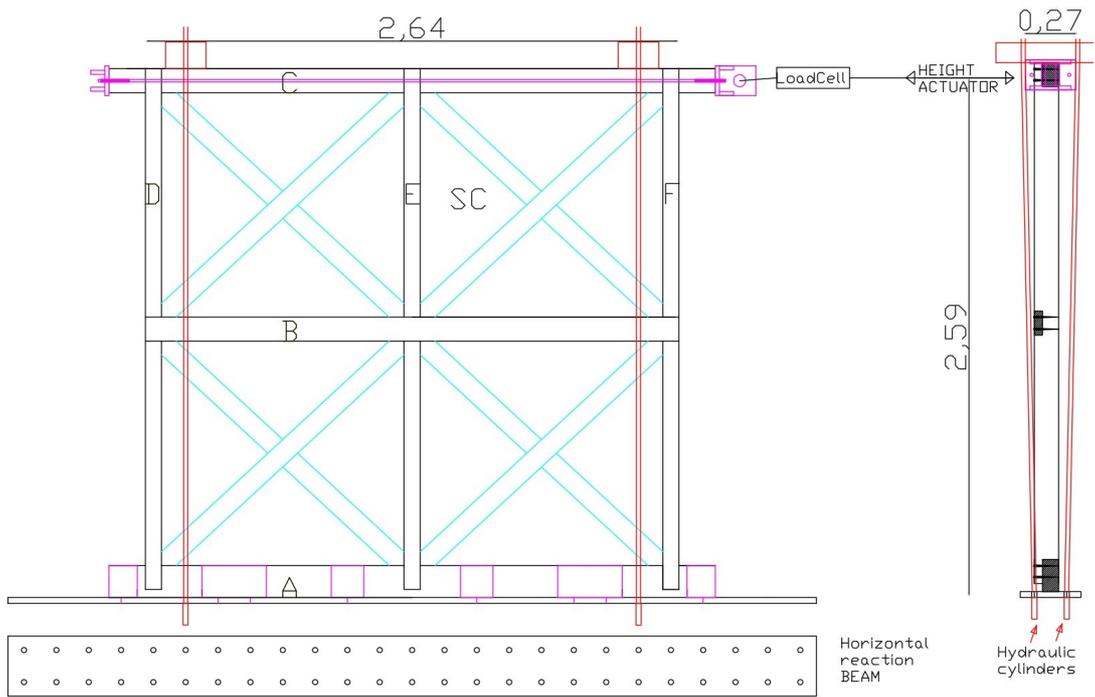
Figure 4: Schematic drawing of experimental set-up of specimen SC (units in meters).

The test specimen described in this section is illustrated in figure 4. Figure 5 presents a photograph of the test frame with a specimen installed and figure 6 shows a schematic drawing of the anchorage system onto the horizontal reaction beam. In figure 6 one can see that the wall SC is anchored to the horizontal reaction beam at the bottom by steel braces in shape of omegas that embrace the lower beam (section 16*8 cm²), which are anchored to the horizontal reaction beam by M24 (353 mm² in section area) screws, as shown in the figure. The anchorage system is very stiff and can firmly take the shear and moment reactions and avoid the rigid body motion of the wall while loaded (uplift forces). A total of 16 M24 bolts were used. This is believed to be a better system for the support conditions of the wall when compared to the possibility of constructing a concrete shoe, as in Pompeu Santos [1997].

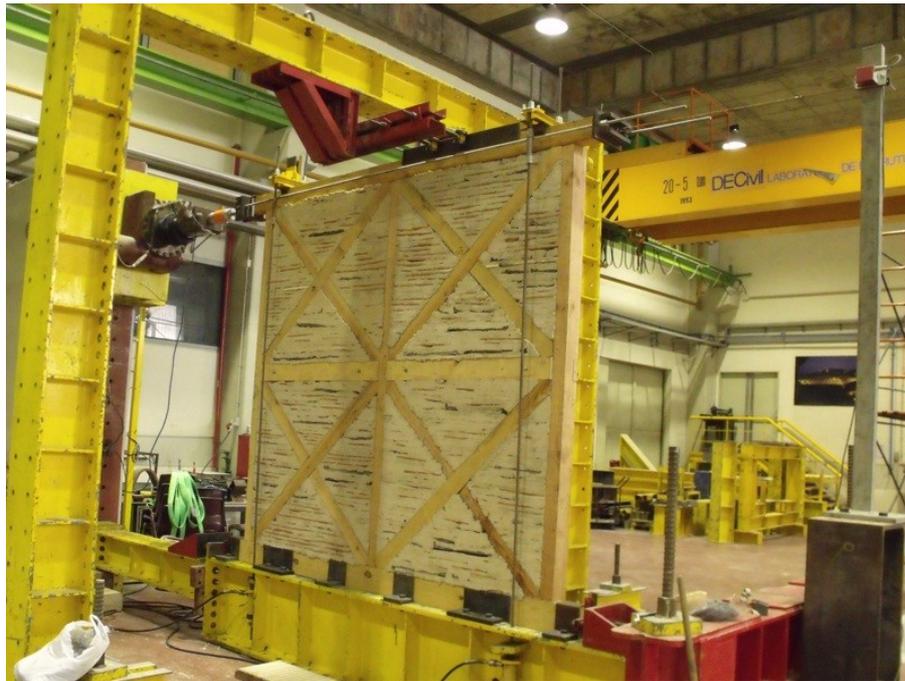
Figure 5: Photograph of specimen SC mounted with final layout.

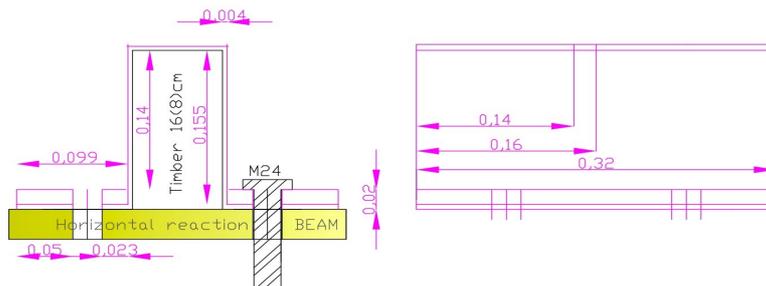
Figure 6: Schematic drawing of the anchorage system (units in meters otherwise specified).

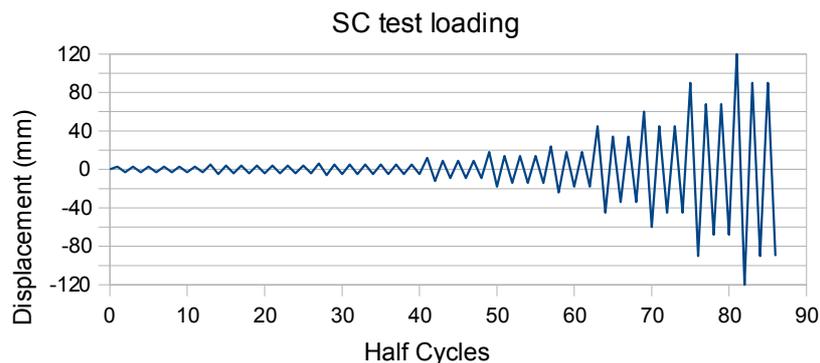
Figure 7: The loading protocol for the tests performed.

The CUREE protocol [Krawinkler *et al.*, 2000] for ordinary ground motions was used to study the cyclic behaviour of the “frontal” walls. This protocol consists of cyclic displacement sequences increasing in amplitude throughout the test; each segment consists of a primary cycle with amplitude defined as a multiple of the reference displacement. The primary cycle is followed by a series of cycles with amplitude equal to 75% of the primary cycle. The sequences of the cycle vary in length from 3 to 7 cycles. The input displacements for each of the tests performed can be seen in figure 7. All tests were conducted such that the initial position of the actuator was at half stroke allowing the maximum deflection in each direction (200 mm). The tests were conducted at a rate of 0.25 mm/s. The data were read at a rate of 1mm/sample as well as, in terms of force, at a rate not higher than 0.25 kN/sample.

In this case study the calculation of the reference displacement was not done, as it would imply one specimen to be tested under monotonic loading like suggested in the CUREE protocol. Instead, is was set a maximum displacement in the loading protocol equal to the maximum displacement obtained at the LNEC experimental testing [Pompeu Santos, 1997], that is 120 mm. Nevertheless, these specimens are one module higher than the ones tested herein; it is for this reason expected that specimens SC1 to SC3 can attain a lower maximum displacement. Accordingly, at experiments of specimen SC1, SC2 and SC3 the structures were seen to stand heavy damage at a displacement of around 90 mm. For security reasons in experiments SC1 and SC2 the experiment was stopped here; nevertheless, in experiment SC3 it was carried out until a displacement of 120 mm since it was the last structures being tested.

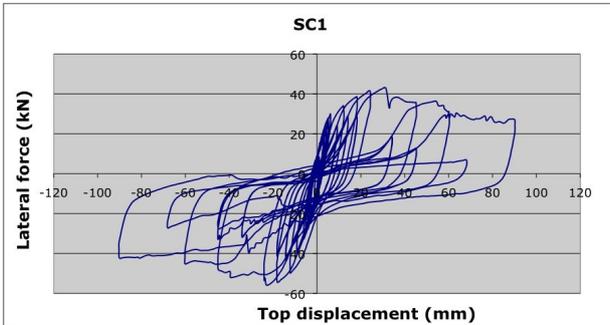
Figure 8: Hysteresis curve of wall SC1.

The obtained hysteresis curves for specimens SC1, SC2 and SC3 can be seen in figures 8, 9a) and 9b), respectively. The hysteretic behavior of the “frontal” walls subjected to cyclic loading are characterized by nonlinear behaviour describing the monotonic envelope. It is also observed pinching behaviour associated with strength degradation and generally fat loops can be identified dissipating reasonable amounts of energy. It is also observed a high ductility of the response. The maximum strength of the walls is around 50 kN. The ultimate displacement obtained without collapse of the structure is around 90 mm, resulting in an ultimate drift of around 3.5%.

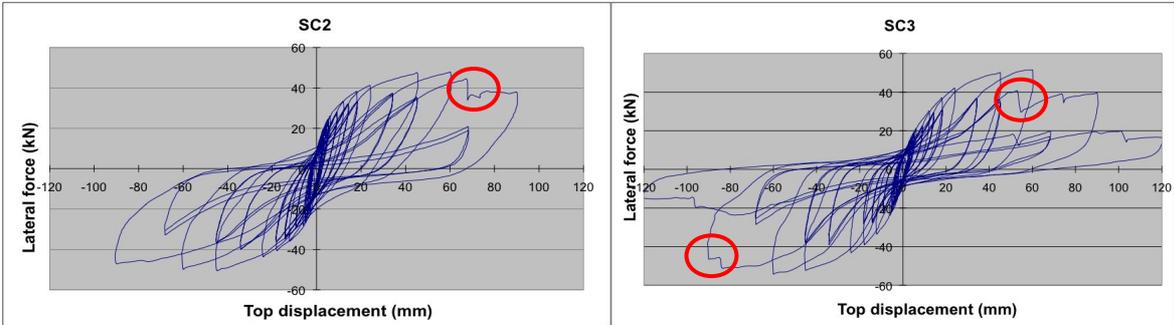
Figure 9: Hysteresis curve of: a) wall SC2, b) wall SC3.

In specimen SC1 the mode of failure was essentially the failure of the connections by cracking of the wood elements at the nodes, see figure 10 a). The failure of these connections in such terms is mainly due to the fact that these were designed as corner connections with no continuity towards the next storey of the vertical wood elements. Nevertheless, in reality it can happen that this continuity of the vertical elements towards the next storey exists, also because it is assumed that the tested walls are placed at the first floor. For this reasons, it was decided to avoid this type of failure in the next tested walls and the upper and lower connections in SC2 and SC3 specimen were reinforced with some steel plates as is depicted in figure 10 b). The mode of failure observed in specimens SC2 and SC3 can be seen in figure 10 c) and is characterized by the buckling and further rupture of diagonals, out-of-plane of the structure. The sudden loss of lateral resistance of the wall when a diagonal ruptures can be observed clearly in the hysteresis curves of figure 9, marked with red circles.

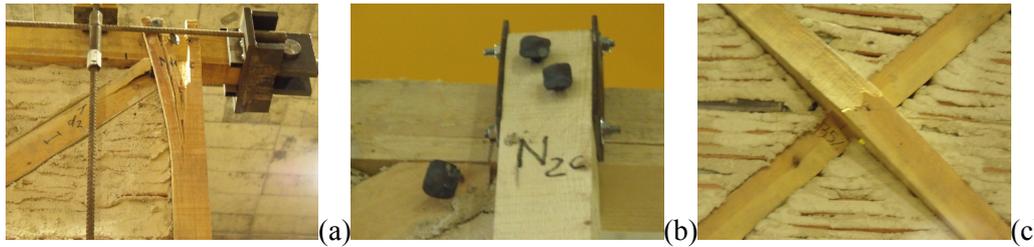
Figure 10: a) failure by cracking of wood at upper connection for wall SC1, b) node reinforcement for walls SC2 and SC3, c) failure by buckling of diagonal for walls SC2 and SC3.
